Jack Pearce, Apprentice Boatbuilder

Zenith Marine, Plymouth

Mid-year progress report, February 2022

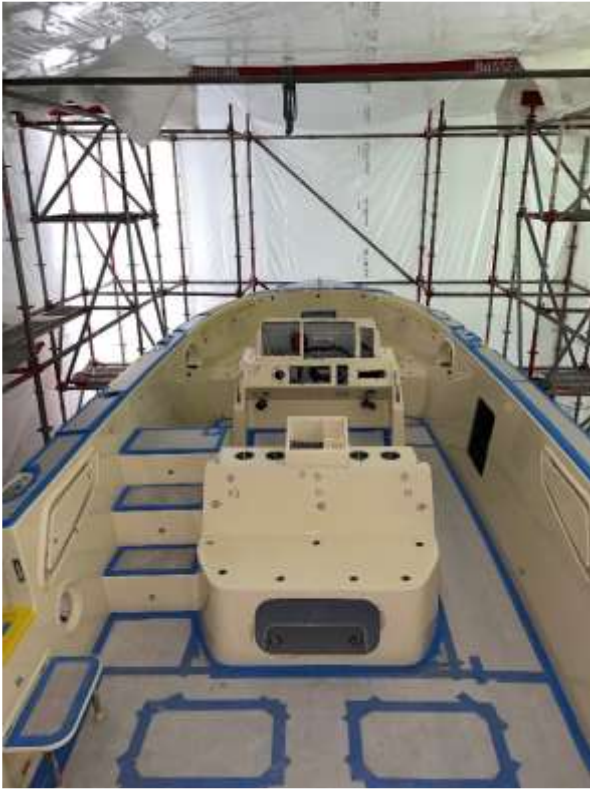
Whilst I was working in Germany, I also got to witness the full effects of managing a big project like this. All the components from including engines, drives, navigation equipment, electrics and teak was removed from the five tenders leaving a bare shell.

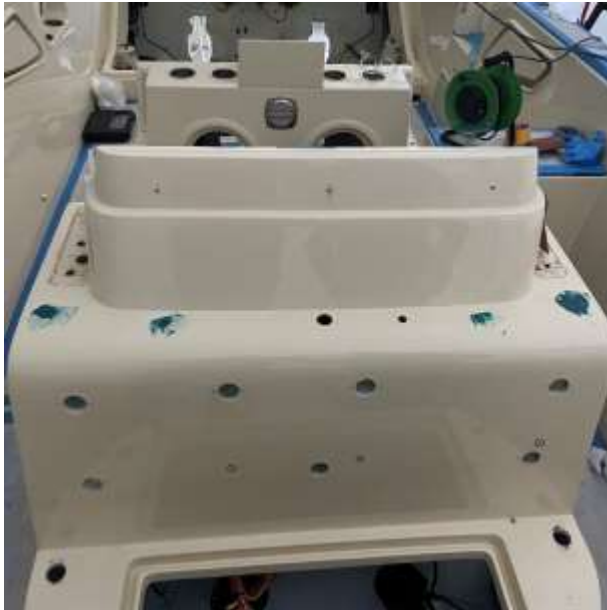
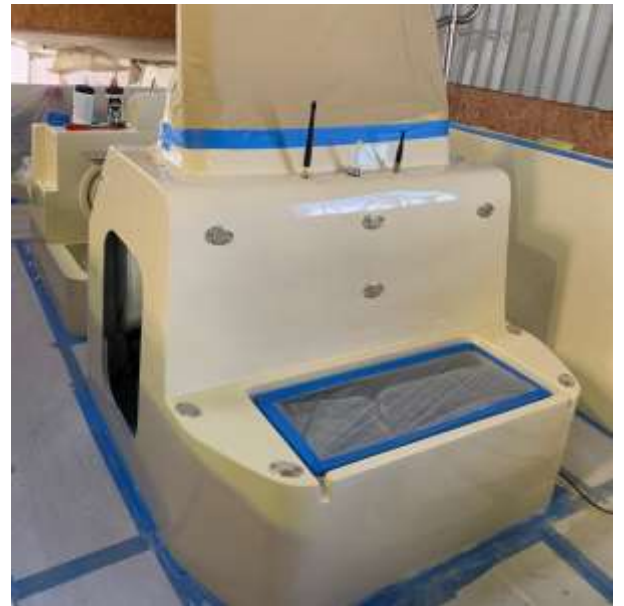
Three of the tenders went into preparation ready to be re-sprayed by a company called PKC, As the other two tenders were gelcoat and not being sprayed, we could start the work on them. A number of repairs were carried out on the GRP from where damage had occurred, this was a skill and challenge I was really looking forward to learning. I assisted with several repairs being carried out step by step giving me an understanding of the process is taken to complete the repair. For example, colour matching with the right amount of pigment and catalyst ratios.

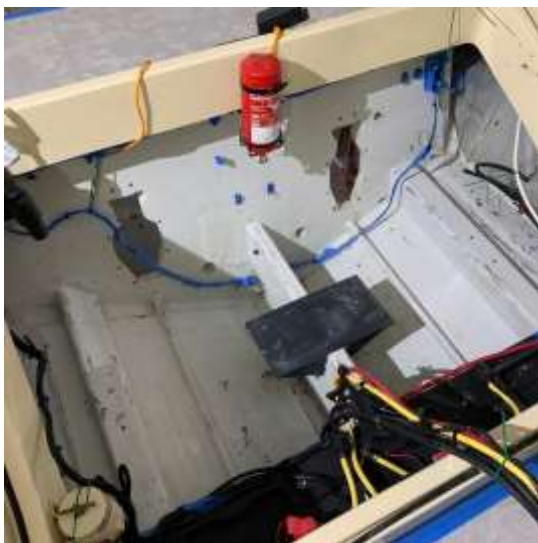
All the engine bays and lockers were etched and received a top/flow coat leaving a brand-new finish, this wasn't something I had not done before and learnt it could have been a very messy job without the right guidance and was very satisfying to see once it was finished.

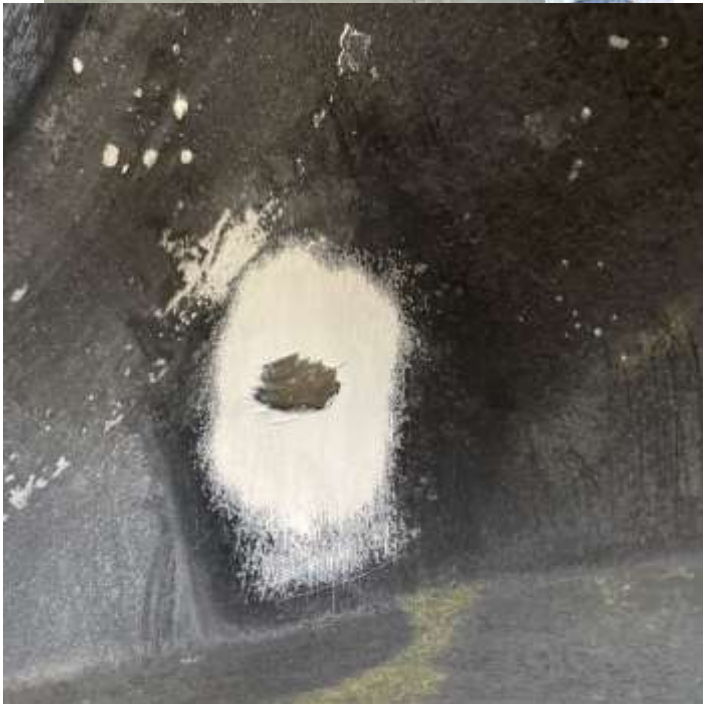
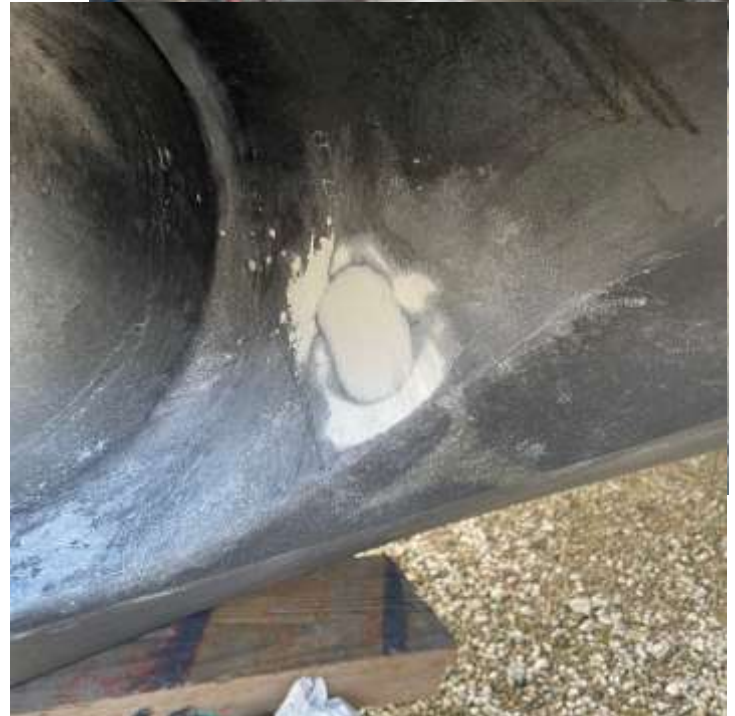
In the UK I have also been learning some underwater repairs, filling in voids and other damages that have occurred. At first this wasn't something I was very confident of completing on my own but after being taught the correct ways to complete these repairs I now have the confidence to start and finish the job by myself.
